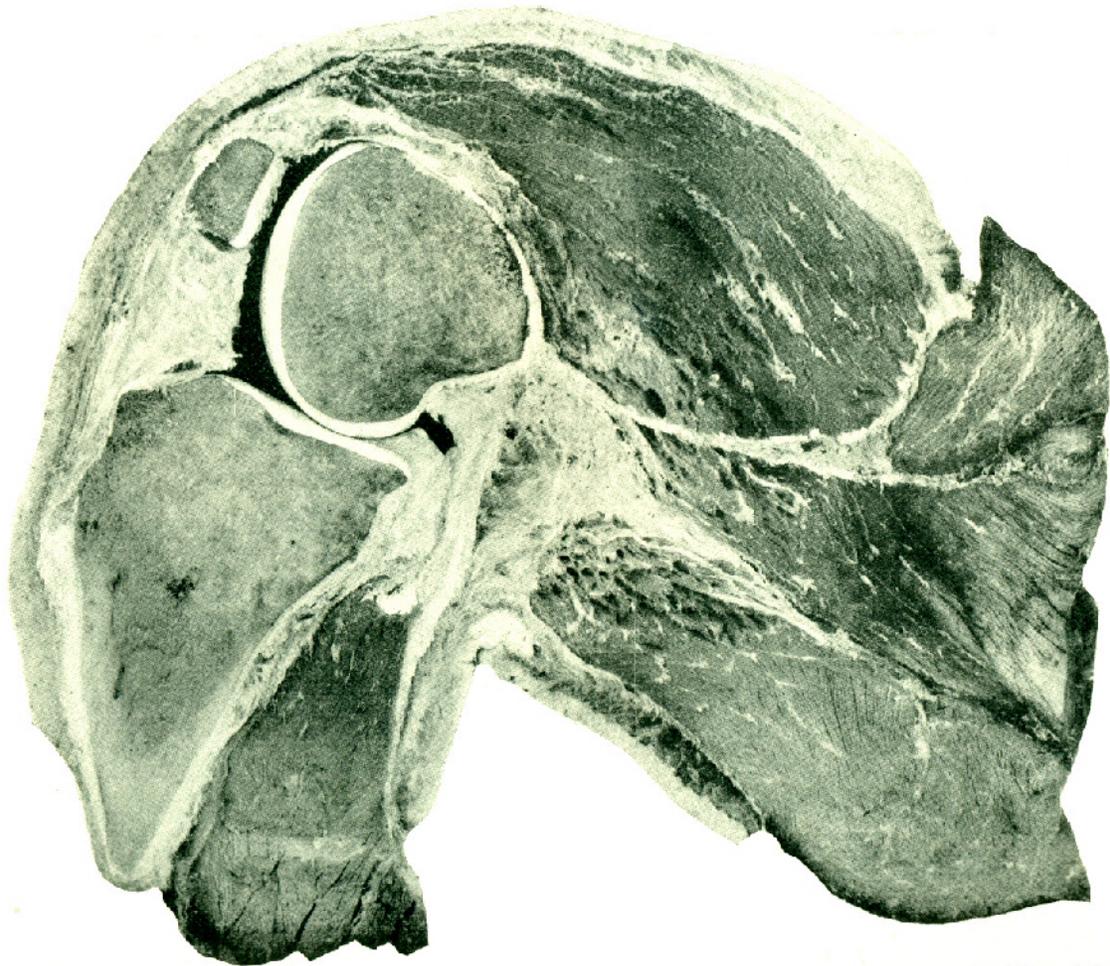
FIG. 191.—Mid section of the amputated limb shown in Fig. 189, with a massive accumulation of large gas bubbles at a level 2 cm. below the surface of the débrided wound. The muscles around this area show the characteristic brick-red color and where the wound tract is near this level there is putrefactive gangrene of the muscles. Accession number 2010, Army Medical Museum. Negative number 32347
