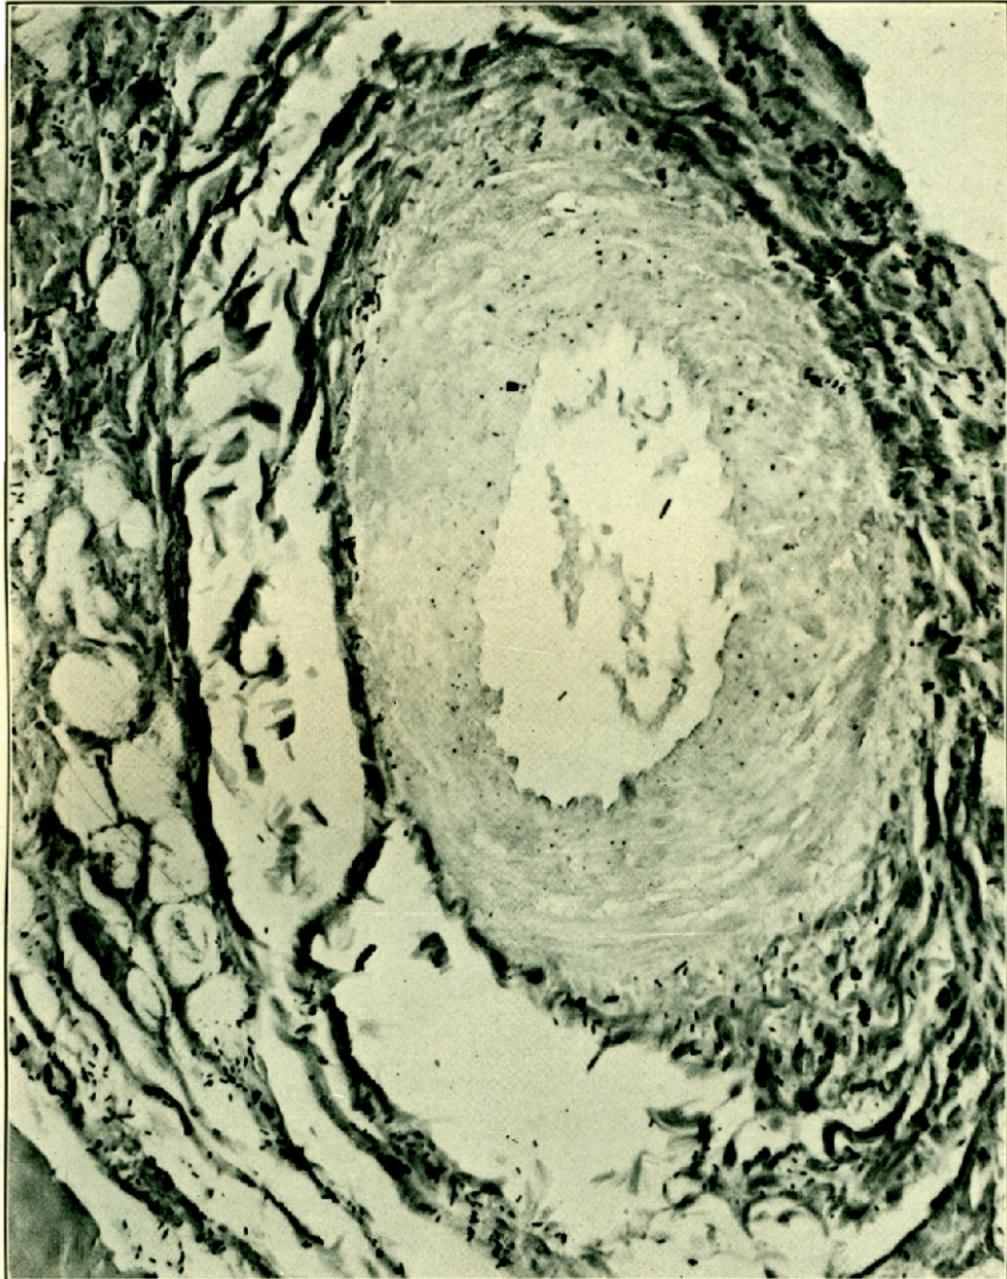
FIG. 253.—Cross section through a medium-sized artery. There is an extreme shredding of the adventitia of this vessel, with gaseous gangrene of the muscular coat. The bulk of this damage is probably due to the effect of the missile and indicates a rupture of the vessel above or below this point. With the rupture below, this is the typical form produced by the missile at a distance from the injury through hydraulic transmission of the force, which resulted in the massive secondary hemorrhages in these wounds. There are numerous bacteria in the walls of the vessel and its lymphatics. One rounded rod occupies a gas bubble in the muscular coat. Accession number 2789, Army Medical Museum. Negative number 46074. MacCallum stain;  $\times 235$
