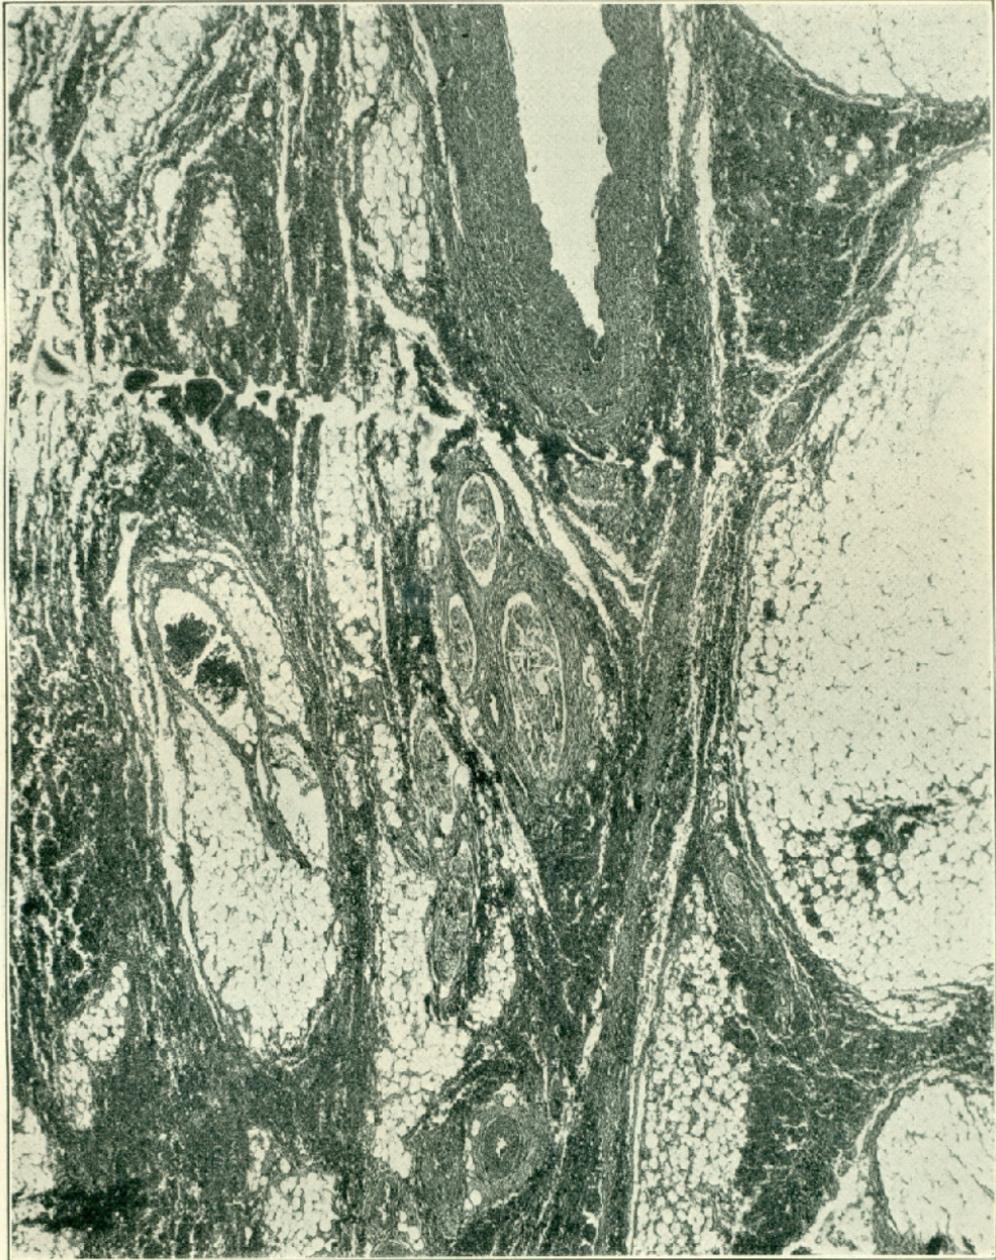
FIG. 292.—Section from the putrefactive area around the larger blood vessels. It includes a missile tract which scores the margin of the posterior tibial artery. The wall of the vessel is split at this point, and a small thrombus has formed on that part of the intima nearest the injury. Two small veins in the left-hand lower portion of the picture near the wound tract show rupture of their walls. This whole area showed considerable hemorrhage undergoing putrefactive changes. Edema and gas are along the wound tract, especially about a bundle of nerve fibers. Accession number 2802, Army Medical Museum. Negative number 46176. Hematoxylin and eosin stain;  $\times 26$
