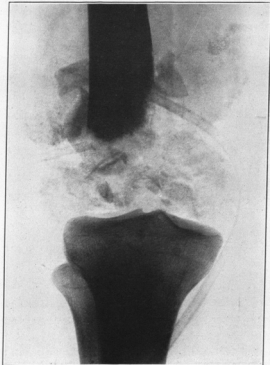
FIG. 38.—Compound, comminuted fracture, lower extremity of femur, with marked dispersion of fragments, resulting in a destruction of both condyles, due to a laterally perforating rifle missile
