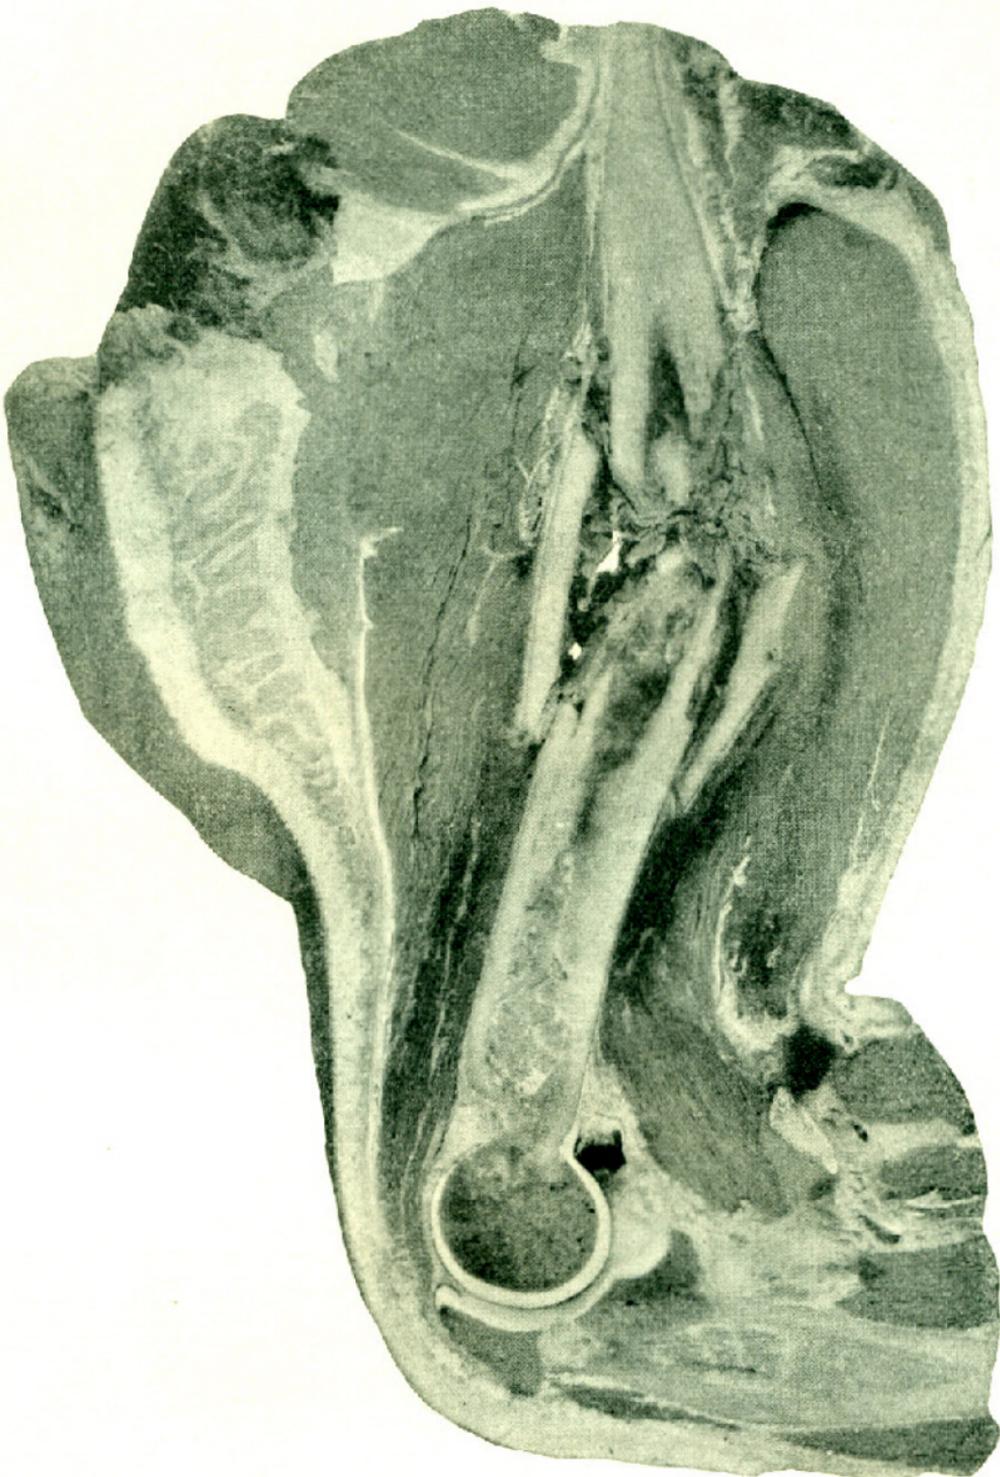
FIG. 258.—Mid section of the arm of the preceding figures showing a beginning putrefactive gangrene around the lower third of the humerus, with some accumulation of gas bubbles in the muscles above this area. There is a fibrinous exudate around the fracture which extends into the marrow of both fragments. The muscles around this point show lack of texture and color typical of the toxic or edematous type of gas gangrene. Accession number 2891, Army Medical Museum. Negative number 32372
