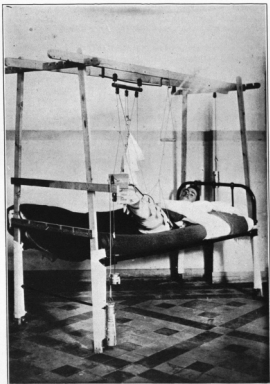
FIG. 78.—Fracture of femur, showing cloth extension. Inverted Hodgen splint
